# **Evaluation of Materials and Building Details for Sustainable Housing Reconstruction in the Gulf Coast of the United States**

This report was done as part of the course work for the class *Design for Sustainable Communities*, conducted by Dr. Ashok Gadgil and offered jointly by the Energy and Resources Group and the Department of Engineering.

University of California, Berkeley  
May 2006

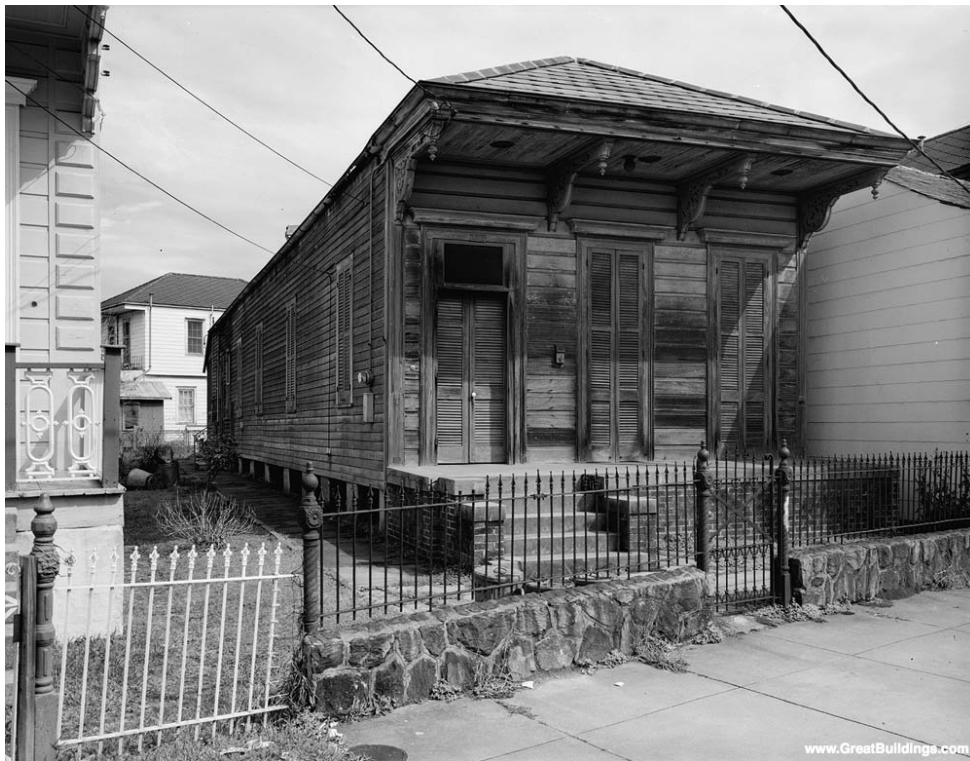
**Figure 2: Shotgun House, New Orleans**

For this project we focused on single-family, detached housing, primarily in the poorer areas of the Gulf Coast, both urban and rural. We also looked at some of the conditions specific to New Orleans. There are a number of prevalent housing types present in the Gulf Coast region. Common houses, especially in New Orleans, include shotgun and colonial styles, mostly fashioned out of wood frames with wood siding on narrow lots (Bernhard and Bernhard). It is uncommon for older houses to have insulation within the walls or ceiling. Many houses are built either on grade or raised on a short crawlspace.

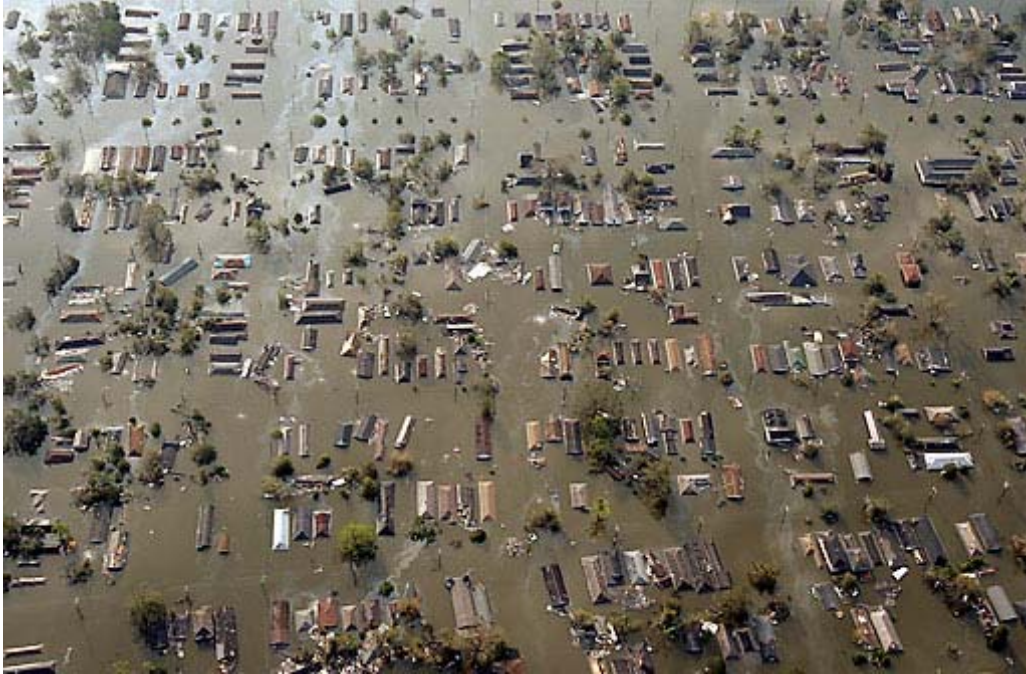
Collectively, both hurricanes resulted in over 1400 deaths and \$108 billion in damages. Much of the damage was the result not only of high winds of over 100 mph but of inland flooding, especially in New Orleans, which is 6 feet below sea level on average (Zarrella et al.).

**Figure 4: Flooding in New Orleans**

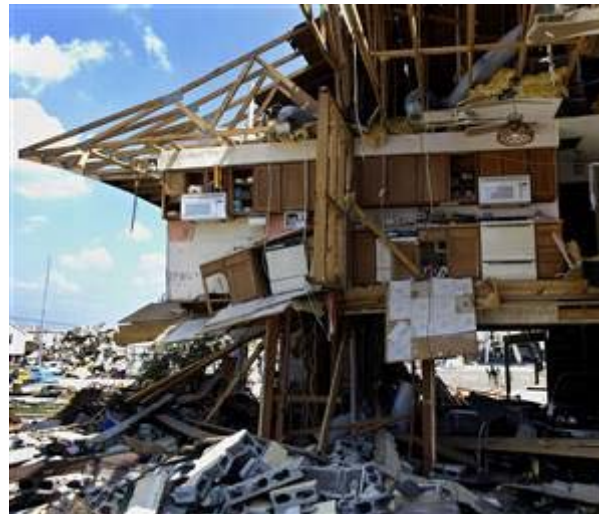
**Figure 5: Image of Wind Damage in Slidell, LA**

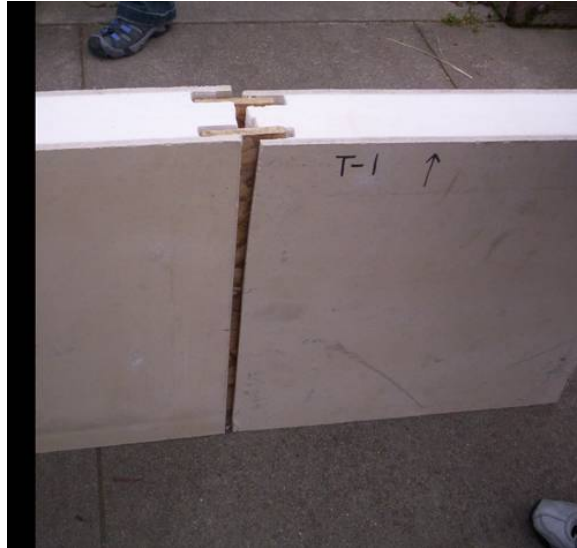
**Figure 7: ThermaSAVE SIP Assembly**

We chose the best two panels of each type and joined them together following our basic understanding of the details provided on the ThermaSAVE website. Joining both the ThermaSAVE SIPs and the OSB SIPs was a very similar process. We used OSB splines for both panel types as we were not aware that our delivery also contained fiber-cement

splines. With both panel types, we experienced the same difficulties of the spline routs being sized awkwardly such that it was difficult to square the total assembly and make both panels flush to each other (see following Figures).

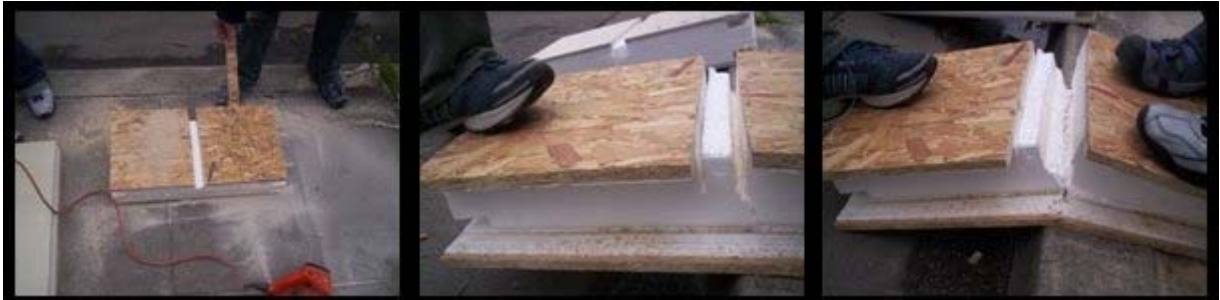
**Figure 9: Conduit Test, OSB SIP**

Both the ThermaSAVE panels and the OSB SIP panels are typically manufactured with part of the interstitial foam routed out to provide a space for running electrical wiring. It is often noted by SIPs users that it is sometimes difficult to line up these conduit runs in the field while assembling panels. Also, some codes require that the channels be greater than 1.25 inches from the nailing surface. One of the ways we have heard of people dealing with this is to rout the necessary channel through the surface of the panel, thus compromising the structural integrity of the SIP system. (Note that this is not an approved means of treating the panels). We were curious as to how the two different types of panels might react to this possible field condition and so recreated the condition in one panel of each type and applied pressure to the side of the panel opposite the rigged rout. The OSB SIP broke after 6 sturdy jumps on the cantilevered side, while the ThermaSAVE panel snapped in two with only the slightest pressure. The question remains which condition would be more desirable in a house – a compromised panel that was still intact (such as the OSB SIP), or a panel that was legibly compromised (such as ThermaSAVE).

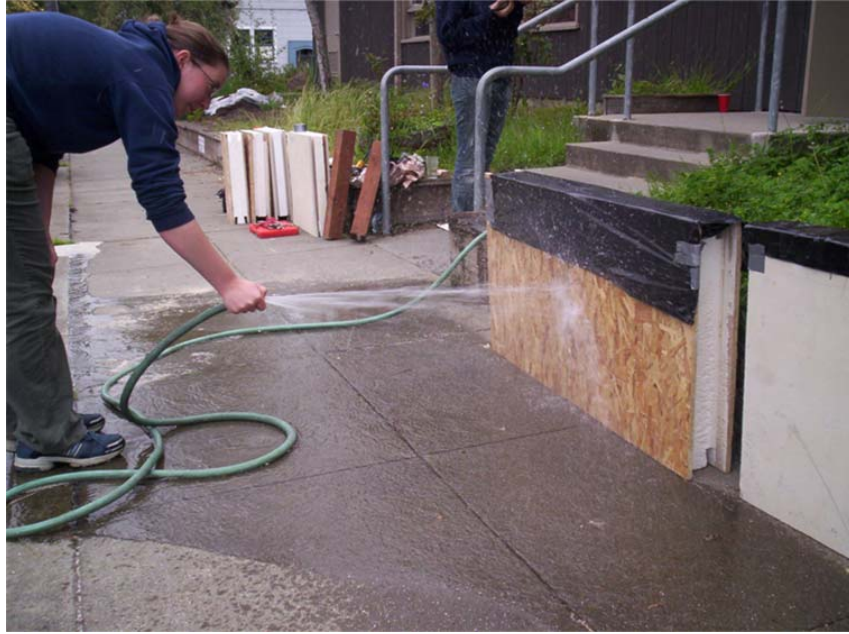
**Figure 11: OSB SIP Joint Water Test**

Finally, we were curious as to the possible transmittance of water through the assembled joint of each panel type as well as the ability of ThermaSAVE to act alone without an exterior drainage plane or cladding. We applied water from a hose normal to the assembled joint (without caulk or sealant) of each panel type from a distance of approximately 4 feet for one minute. Neither panel exhibited any water transfer from one side of the joint to the other in this test. Further tests may be necessary to determine the effect of continuous driving rain on the assembly detail of each panel type.

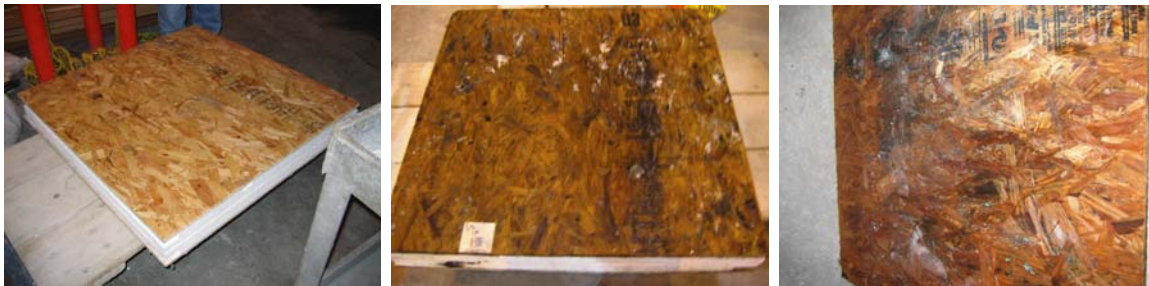
**Figure 13. OSB SIPs: Dry, Moist, and Wet Panels**

We placed one panel of each type into a moisture chamber set at 95% relative humidity for five weeks, simulating humid weather conditions, which we called the “moist” setting. In the same moisture chamber room, we immersed a pair of standing panels approximately 1.5 feet deep in standing water, which we called the “wet” setting<sup>1</sup>. The third pair of panels was left “dry,” outside of the moisture chamber room.

We also noted the conditions of the panels before and during testing, as shown in Figure 13 and Figure 14. The dry OSB and Thermasave panels did not look any different than their initial conditions, five weeks prior to testing. All moist and wet OSB and the wet ThermaSAVE panels developed brown, black, blue, green, and white molds on their edges and faces. The mold on the ThermaSAVE panels could be easily wiped off, unlike the mold on the OSB. The moist and wet OSB SIPs also exhibited expansion of the OSB sheathing and were soft to the touch.

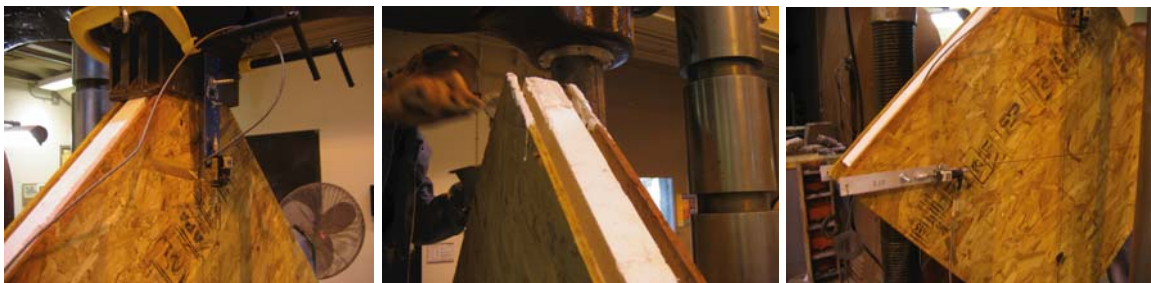
**Figure 15. OSB SIP Dry Panel Preparation**

For the testing process, we first prepared each of the three OSB specimens. We inspected each panel and recorded our observations. We chose the most similar and square set of opposite corners as the corners to be loaded in the testing process. We placed the two opposite loaded corners into steel loading shoes (see photos) and kept them in place with hydrostone. The hydrostone served as a filler and bonder between the panel corner and the steel shoe. The purpose of the steel shoe was to help distribute applied load throughout the panel. We installed two pairs of gauges, one attached horizontally between bolts at the corners of the panel, and one pair attached vertically between the loading shoes, on each side of the panel. We set one pair of gauges to measure deflection vertically, in the direction of the load, and the other horizontally.

In Figure 15, a pair of gauges, not shown, connected along the horizontal line measures elongation along that line due to shearing, as the panel is being loaded; the vertical gauges, one of which is shown, measure vertical shortening.

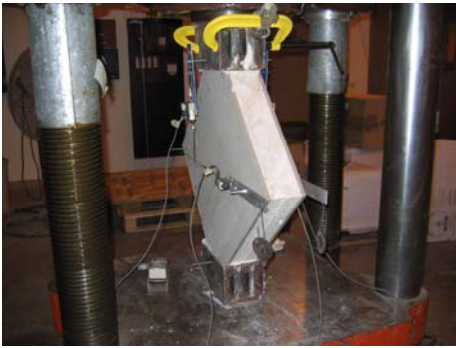
**Figure 16. ThermaSAVE panel (dry) loaded in testing machine**

Each of the ThermaSAVE panels that we received was damaged in transport such that no panel had two opposite undamaged corners that could accommodate the loading shoes. We dealt with this by cutting the panels down to 2 feet square. Though this meant that the OSB SIPs and ThermaSAVE panels tested were different sizes, it did allow us to obtain better data for comparison between the ThermaSAVE panels. We still compare data to the 3 foot square OSB panels with this in mind. After cutting the panels down, we followed the same panel preparation procedure as that for the OSB SIPs.

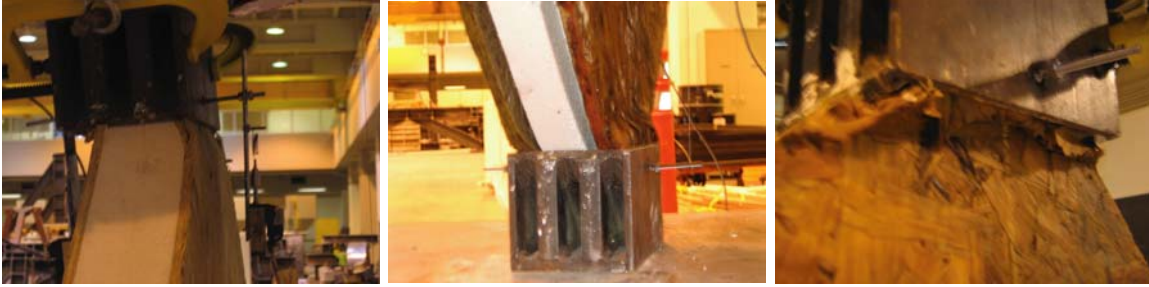
**Figure 17. OSB SIP Failure Points: Dry, Moist, and Wet**

All of the panels failed in a similar manner during testing by the development of a crack in the panel corner along the edge of the top steel shoe. Corner cracks in the OSB panels, however, were much more jagged, while cracking in ThermaSAVE was more linear and clean-cut with occasional delamination between the fiber cement and the EPS core near the loading point. The moist and wet OSB SIPs produced less of a defined crack and more of a brooming effect where the OSB fibers were simply crushed.

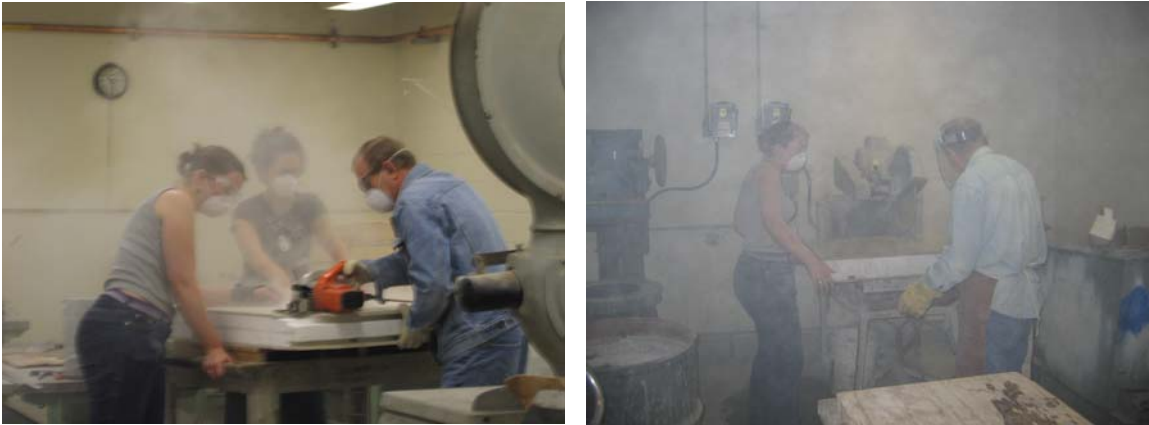
**Figure 19. Cutting ThermaSAVE panels**

It is also worth noting that the ThermaSAVE panels released a considerable amount of dust while being cut (Figure 19).

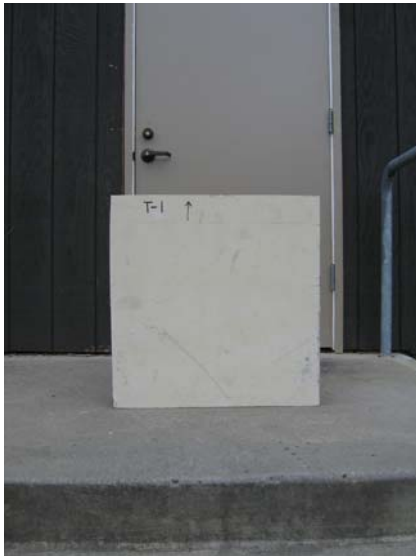
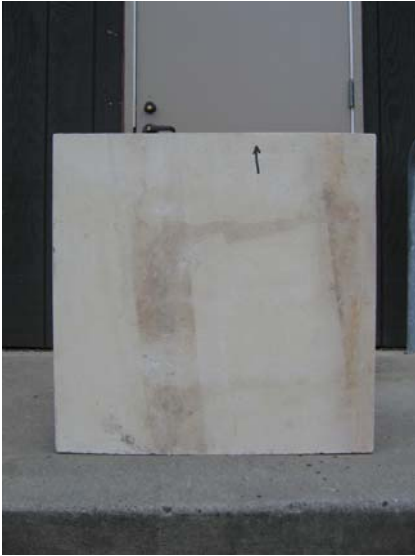
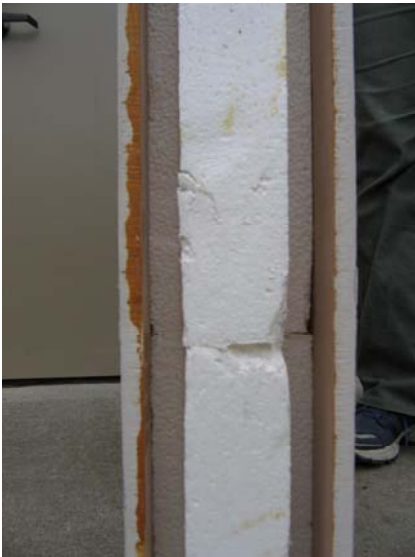
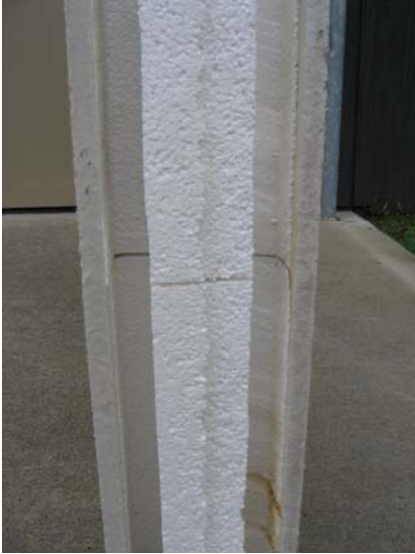
T-2

Sheathing

- Big crack on upper front left corner
- Dent on upper front center
- Back left upper corner separating

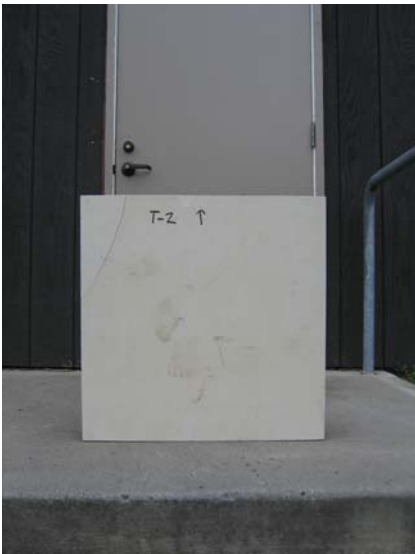
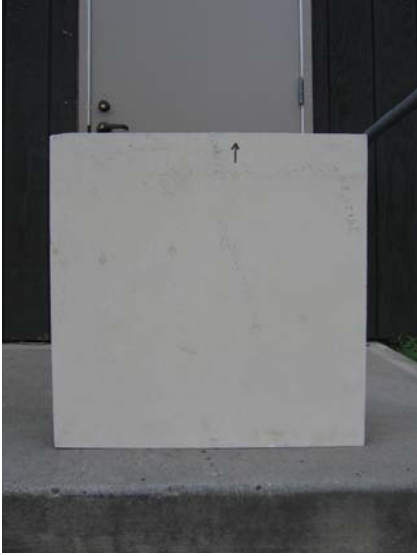
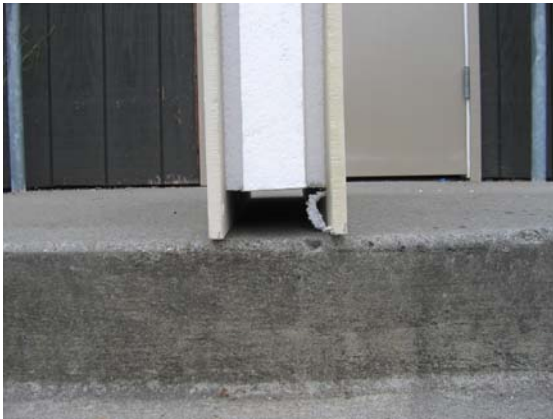
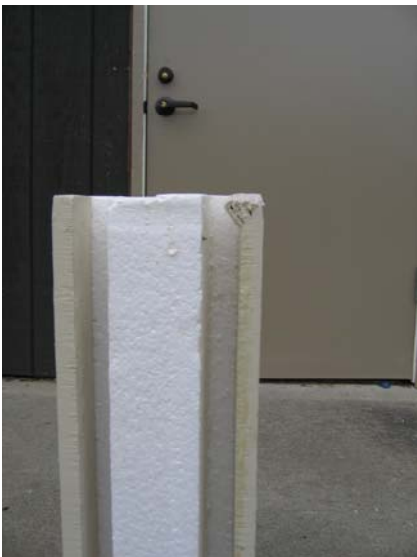
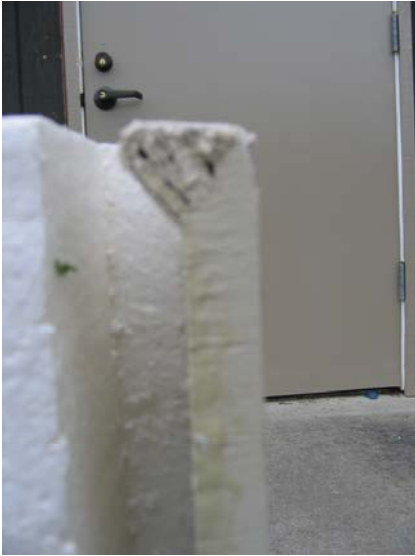
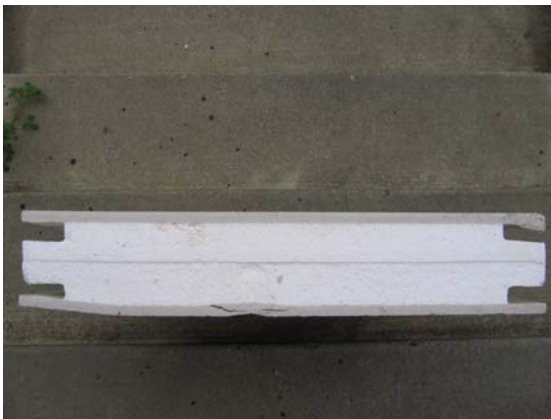
T-3

-Horizontal conduit

- Flush with front and centered vertically
- Sheathing
- Large crack in front lower left
  - Dent in upper left front
  - Dent in bottom front center
  - Crack in front bottom right corner

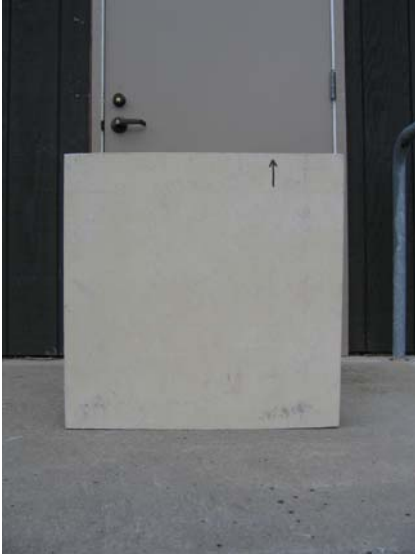
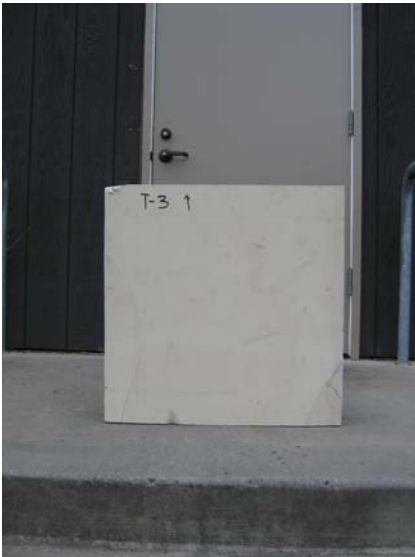
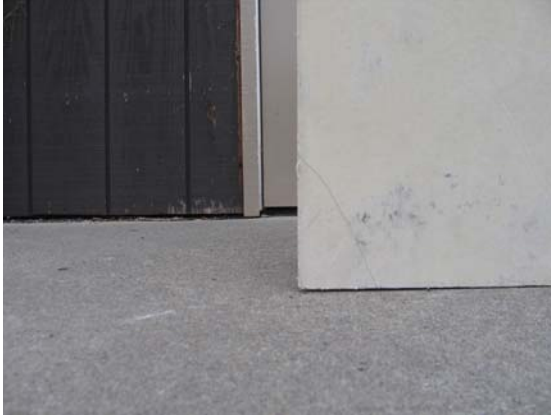
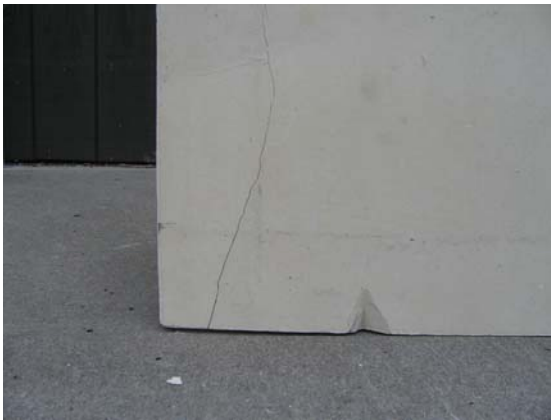
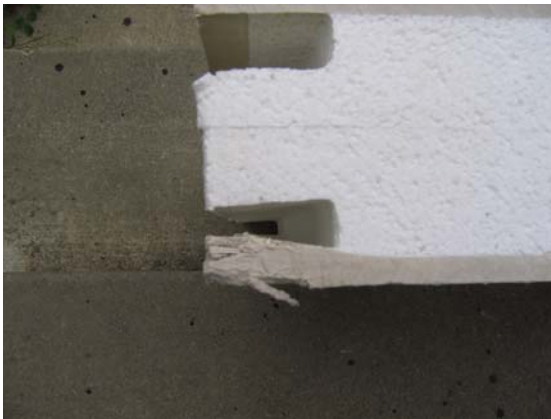
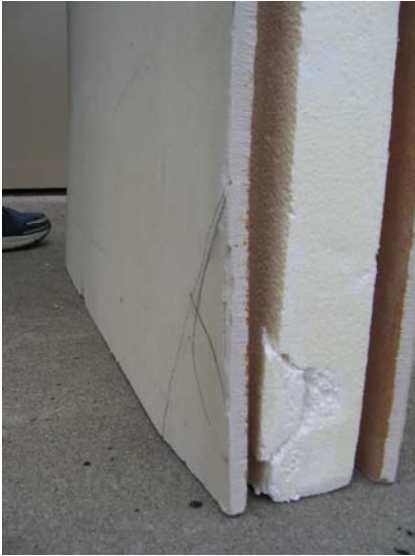
T-4  
Routs  
-Opposite vertical routs for splines  
-Top and bottom flush  
Conduit  
-No conduit

## Sheathing

- Dent in front upper left corner
- Dent in front bottom left corner
